Case Study- Comparison of existing tube inspection technology (ECT) with Acoustic Pulse Reflectometry (APR)

Inspected Equipment: Condensate Stabilizer Reboiler

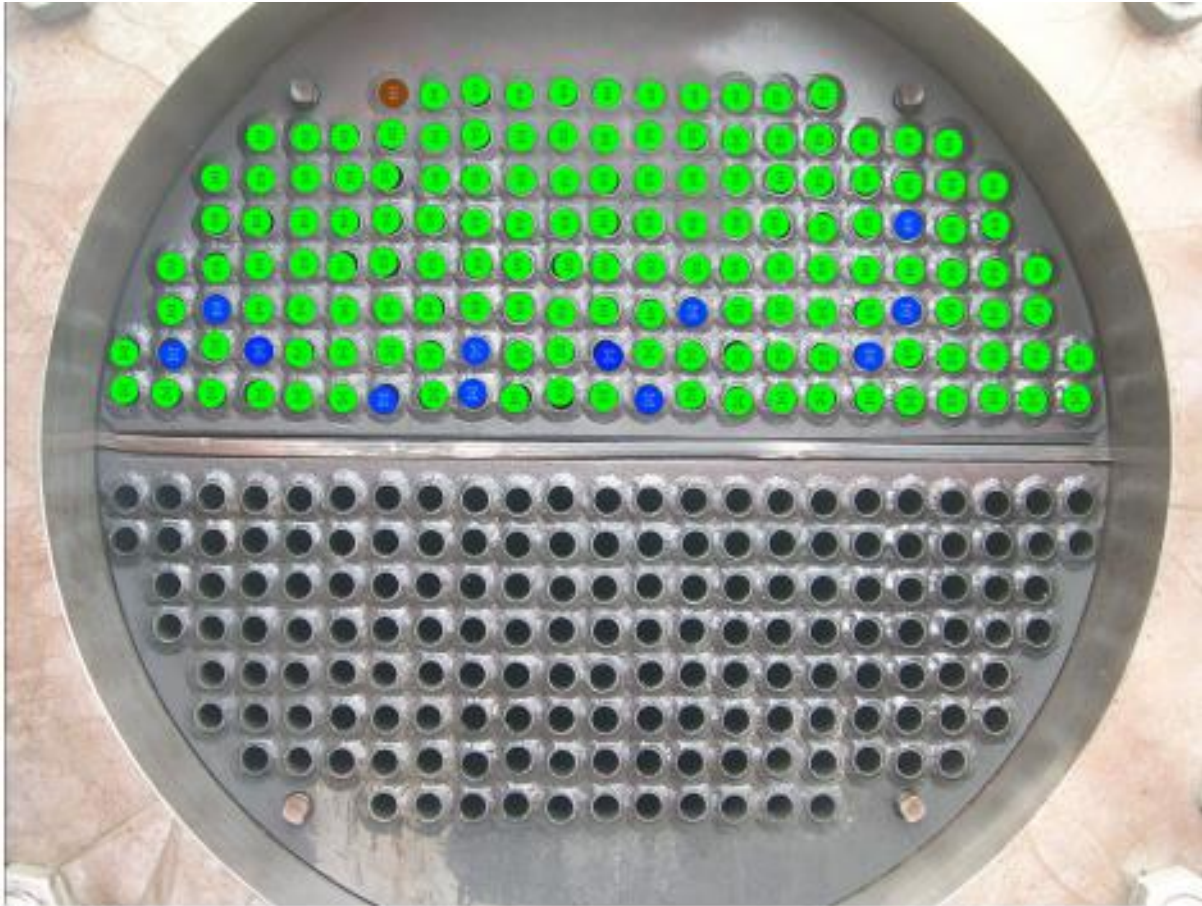
After 2.5 hr duration, inspection personnel informed that report was ready to be issued. The defect table from the report was highlighted as follows:

Tube No	Faults								Row	Tube No
	Hole		Blockage		Erosion		Pitting			
	Position	Diameter	Position	Reduction	Position	Reduction	Position	Reduction		
	[m]	[mm]	[m]	[%]	[m]	[%]	[m]	[%]		
1	9.66	3.3							4	48 to 66
64							3.46	21.7	5	67 to 87
89							5.95	28.4	6	88 to 108
100							1.11	21.1	7	109 to 131
105							5.91	24.6	8	132 to 154
110							5.48	27.8		
112							7.56	44.7		
117							6.88	28.3		
120							8.15	57.2		
126							6	29.4		
138							5.85	26.9		
140							6.29	27.2		
144							5.89	32.1

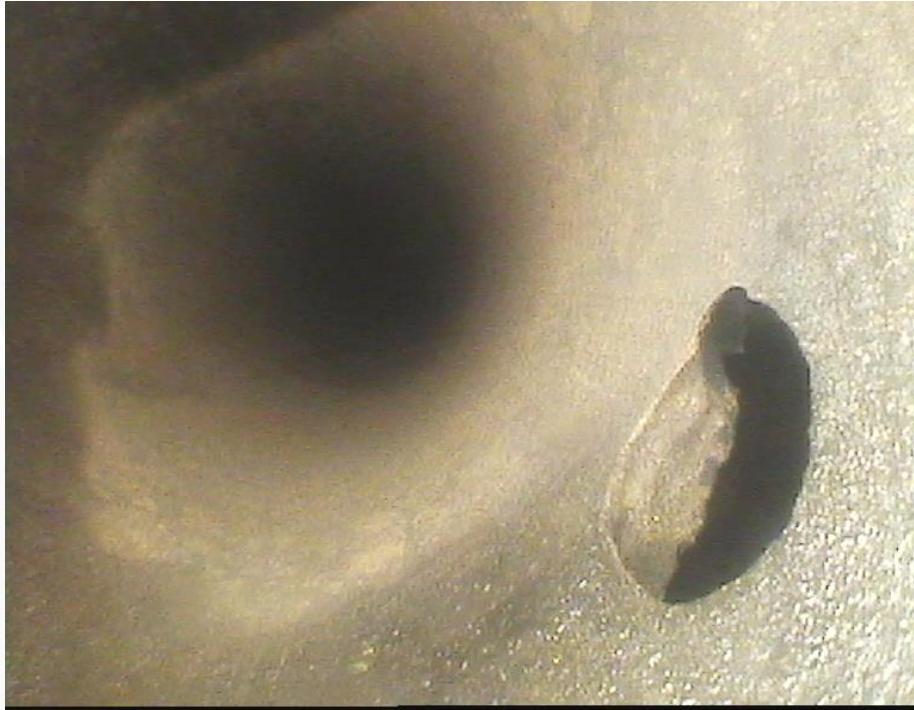
APR Tube Numbering	APR Defect indication	ECT Tube Numbering	ECT defect indication
1	Hole/leak of 3.3mm at 9.66m	R[1] C[1]	60-80%
112	Pitting of 44.7% wall loss at 7.56m	R[7] C[3]	40-60%
120	Pitting of 57.2% wall loss at 8.15m	R[7] C[12]	40-60%

Fig 1: Leakage at 9.66m in R[1]C[1]

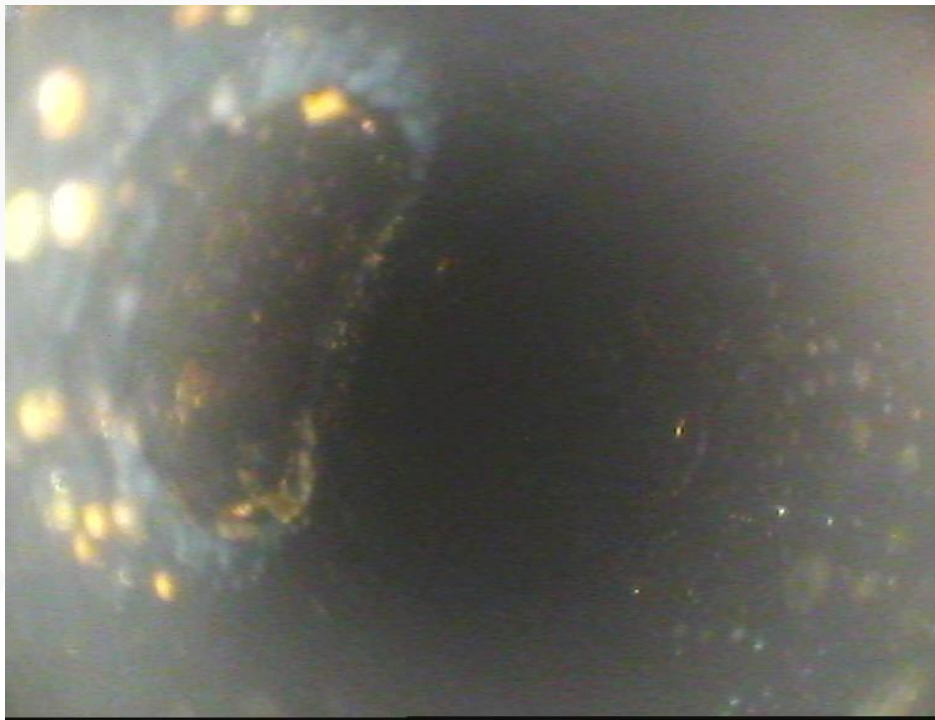
Fig 2: Wall loss at 7.56m in R[7]C[3]

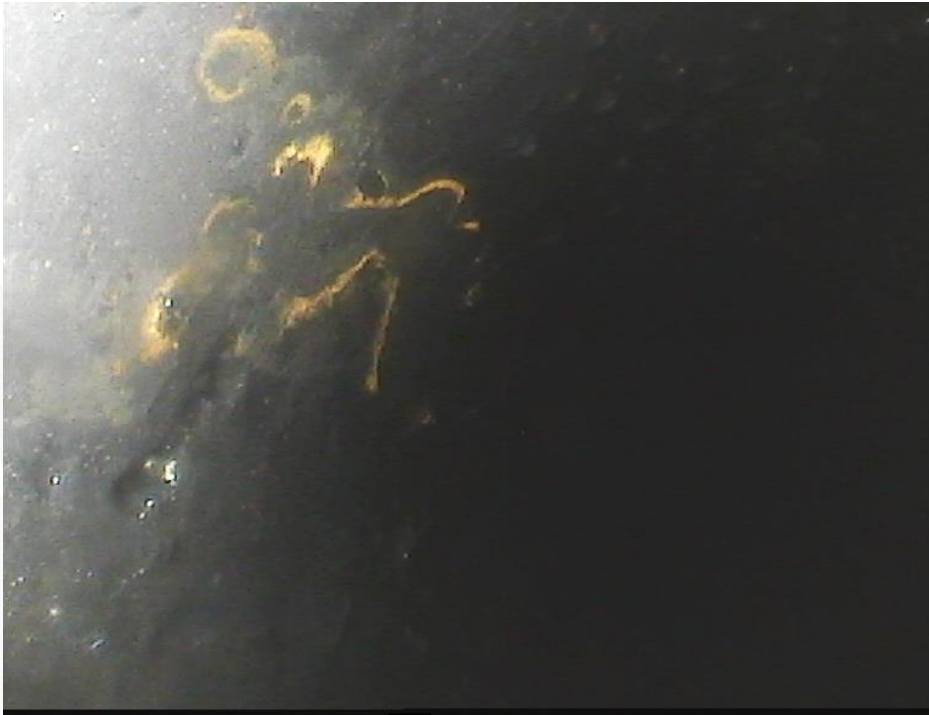
Fig 3: Wall loss at 8.15m in R[7]C[12]

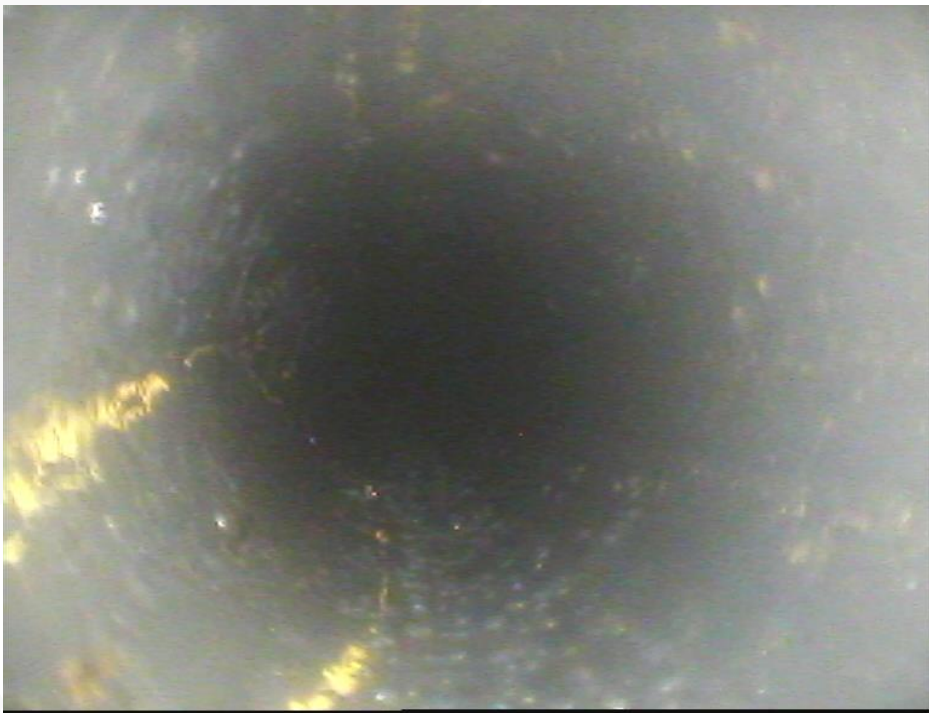
Fig 4: Wall loss at 6m in R[7]C[18]
