INSPECTION OF COOLER TUBES IN A MINING PLANT

DATE OF INSPECTION	5 Apr 2020	TOTAL NO. OF TUBES	452
LOCATION	Chile	TOTAL NO. OF TUBES INSPECTED	420
INSPECTION SITE	Atacama	CONFIGURATION OF TUBES	Straight
END CUSTOMER	Planta 2	TUBE OUTER DIAMETER	19.05mm
COMPANY PERFORMING INSPECTION	Ingal	TUBE THICKNESS	1.6mm
DESCRIPTION OF INSPECTION	Cooler Tube Inspection	TUBE LENGTH	9.1m
INSPECTION TECHNICIANS	Rafael	INSPECTION STANDARD	ASTM E2906/E2906 M-13/ASME BPVC 2019

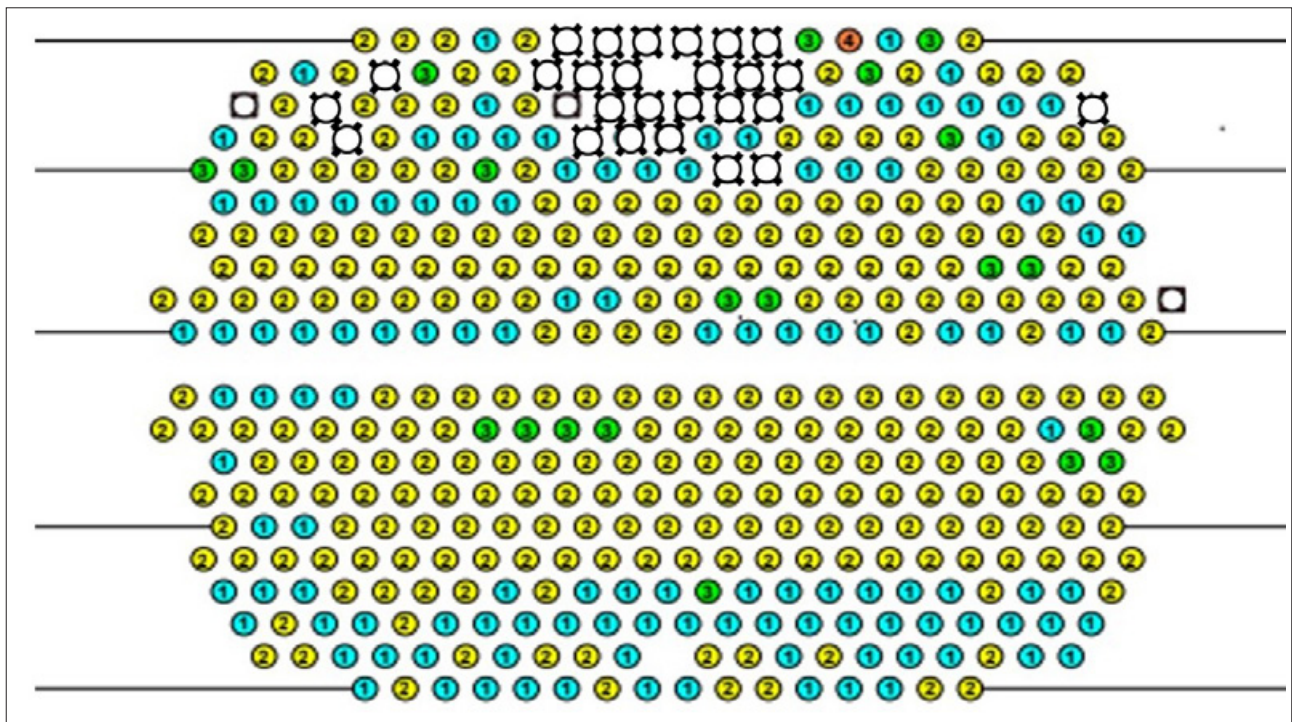
Figure 1: Tube mapping of the Heat Exchanger

DEFECTS	NO. OF TUBES
Blockages	31 tubes
Wall loss (>60.1%)	2 tubes
Wall loss (40.1% - 60.1%)	11 tubes
Wall loss (20% - 40%)	370 tubes

Tubes that are reported as wall loss greater than 60% are plugged by the maintenance team. After plugging the tube, hydro test was conducted on the cooler and no leaks were reported.

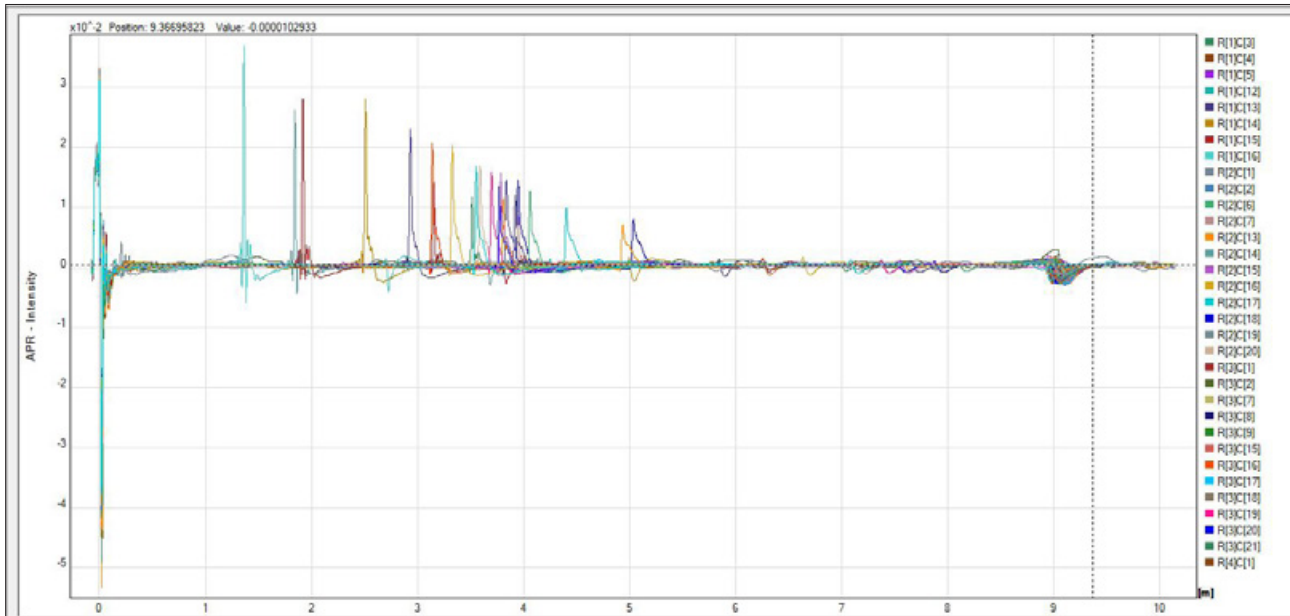
Figure 2: Signals indicating defects.
